Dunadd Community Enterprise

Conservation Assessment - Kilmartin Church

Kilmartin Parish Church, Kilmartin Village (excluding Scheduled Monument No 13316 'Kilmartin Churchyard, Crosses, Tombstones and Neil Campbell Tomb' (LB11490)

Shauna Cameron Architect

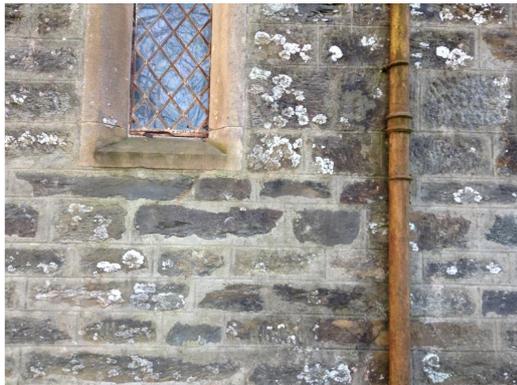
North Elevation, showing decayed window & damaged downpipe

- Pointing at sandstone mouldings at doors and windows: carefully rake out joints and re-point using sharp sand and St Astier NHL 5 sand/lime 2.5:1 mix by volume, flush.
- At exposed foundation stone work (mainly east elevation), at buttresses, re-point as above.
- Check all rainwater downpipes for cracking, replace with like for like as required.
- All gutters and down pipes at clerestory to be checked for cracking and vegetation growth, particularly on south elevation. Replace with like for like as required.
- Lead roofs to aisles to be checked and repaired with code 8 lead, as existing. Parapet gutter and overflows check for blockages.

- External surface water drainage to be exposed, traps added at ground level and route to soakaway exposed and repaired as required. Drainage channel to be installed in front of south door in east elevation as west door.
- Cast iron lights, re glazed as required with appropriate glass (thickness & quality). Some windows may need removed and refurbished, by specialists. In particular the east tracery lights and some single lights in the north elevation.

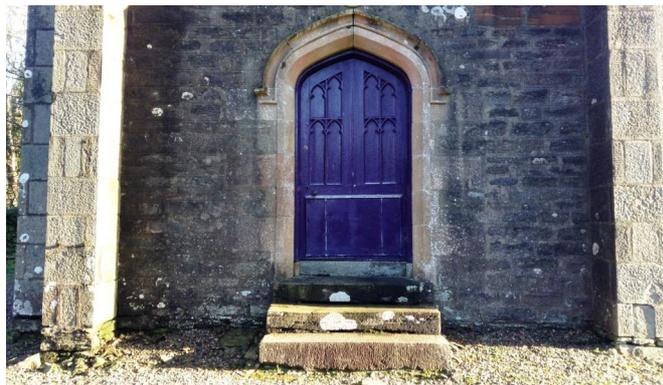
Steps at west

Back steps poor.

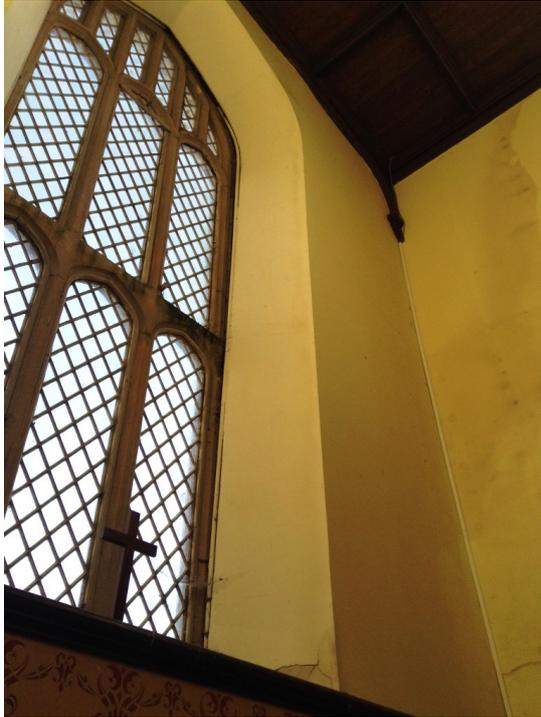
Tracery window comes- see external notes.

Decay at tracery window

Strapping and lining at window opening considerably decayed. Remove and replace any decayed lath, like for like and coat with suitable lime plaster.

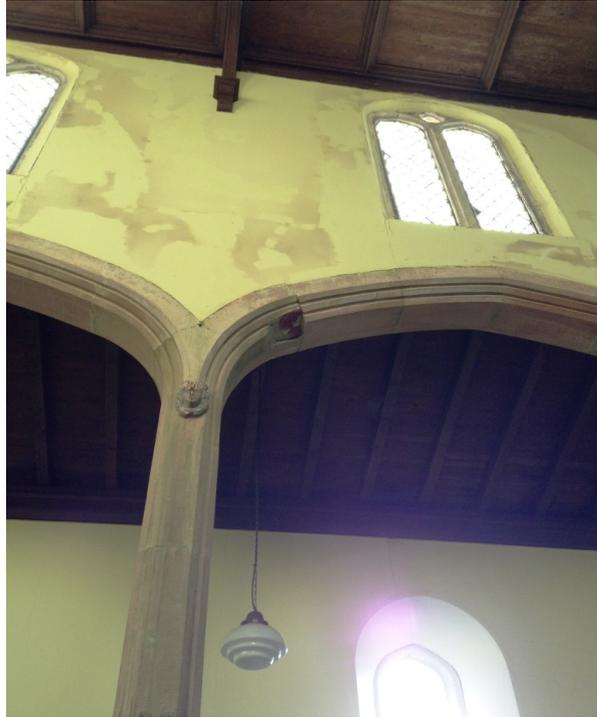
Damp at upper part of south wall

Entire wall showing signs of moisture penetration. This may be historic or maybe the result of issues at gutter level. It may be necessary to remove the damaged plaster and re-coat as above. If historic and the source of water penetration has been repaired, the wall may dry out and it may be possible to repaint with an appropriate breathable paint.

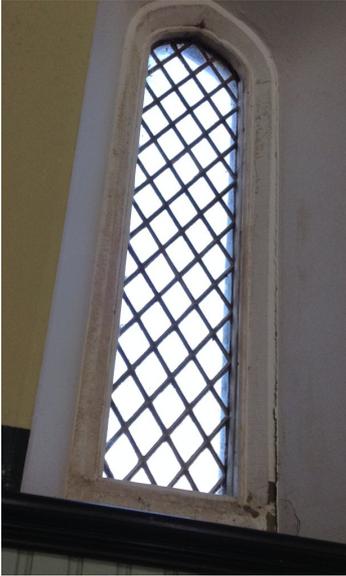
Decayed cast iron window

Repair work round cast iron windows at ingoes will be required.

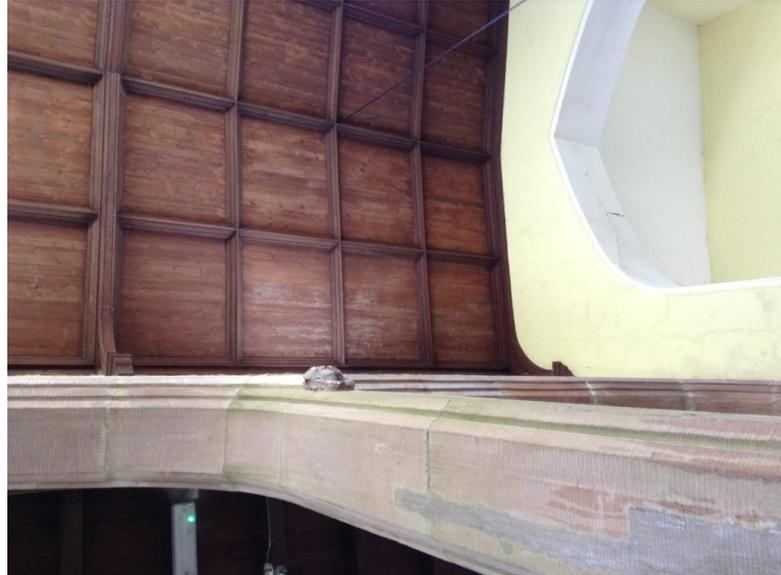
Possible water ingress (historic)

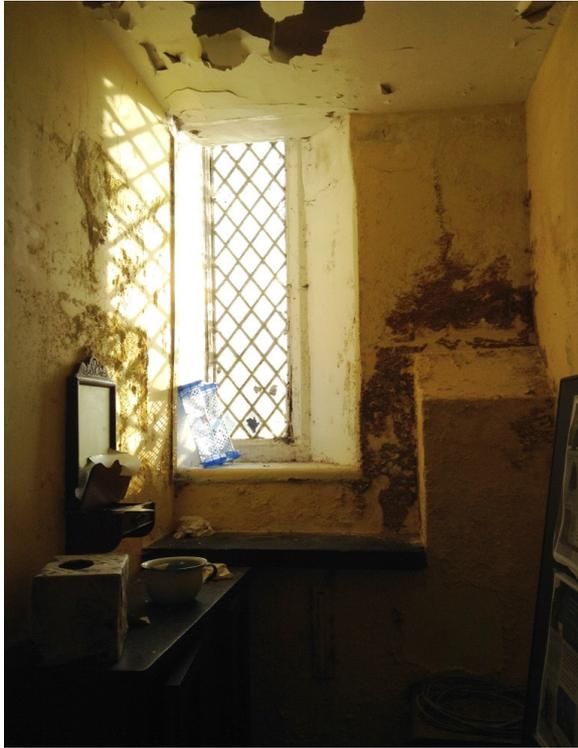
Decay showing considerable efflorescence (salts)

Considerable efflorescence (salts) at vestry fire place/boiler flue. See above.
Rear stair not accessible, but assume south wall affected by efflorescence.

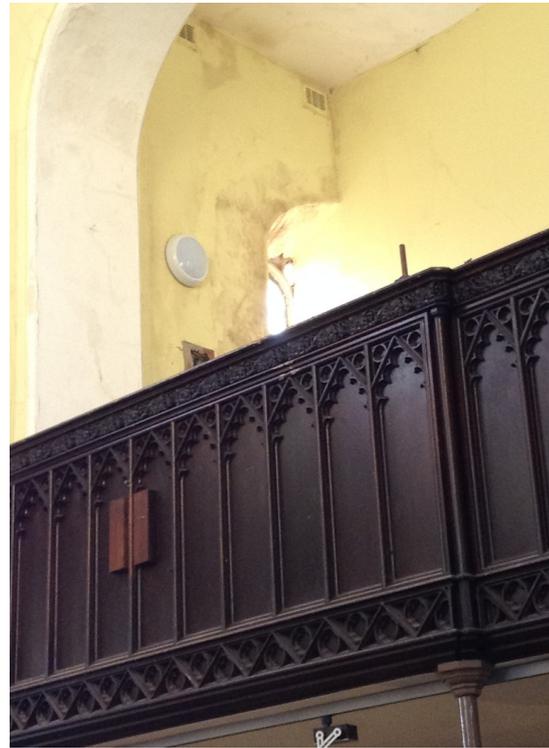
Gallery showing efflorescence at flue

South wall and junction with stair wall, considerable efflorescence (salts). Ventilators (FAI's) have been added to attempt to dry the wall out. The source of dampness is likely to be the flue and the resultant cracks in the masonry. When this has been repaired as water proofed (but still ventilated), it is likely that the salts will dry out or at least improve. It may be prudent to remove the plaster, exposing the lath until the external wall has dried out.
